Manhole Inspection Summary

Manhole # S45C__067MH

Insp Date: **8/15/08 10:08 AM**

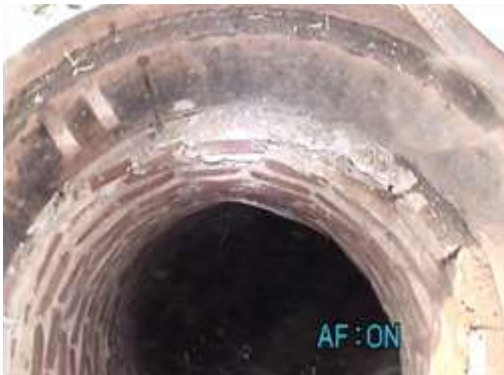
Defect 2

☒ **Leaks**

Frame Leaks

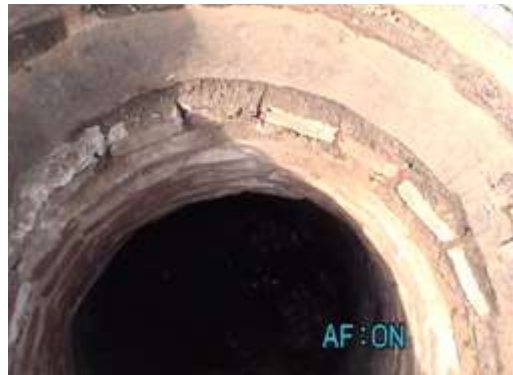
Defect 1

Condition: ☐ Sound ☐ Cracked ☐ Root Intrusion ☒ **Loose Brick** ☐ Deteriorated

Infiltration: ☐ None ☐ Joint ☐ Cracks ☒ **Mortar** ☐ Roots ☐ Wall

Loose Brick

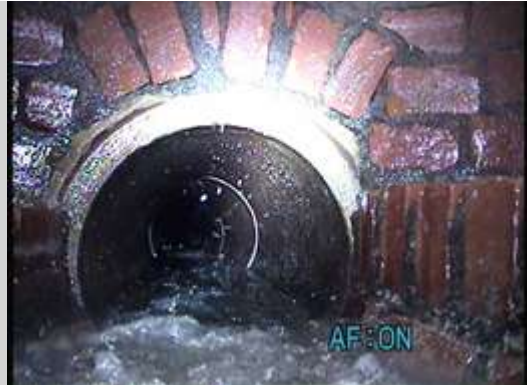
12 O'Clock Outflow

15 in. Circular Gravity Sewer
Pipe Out @ 12 O'Clock

Pipe Height: **15.6** (in.) Rod and Bar (Angled)
Pipe Material: **Clay** ☐ Pipe Lined
Invert Depth: **12.70** (ft.) Flow Characteristics: **Fast**
Deposits: ☒ None ☐ Mud ☐ Sludge ☐ Debris ☐ Grease
Silt Depth: (in.) Deposits Extent:
Infiltration: **None** Pipe Seal Cond: **Sound**

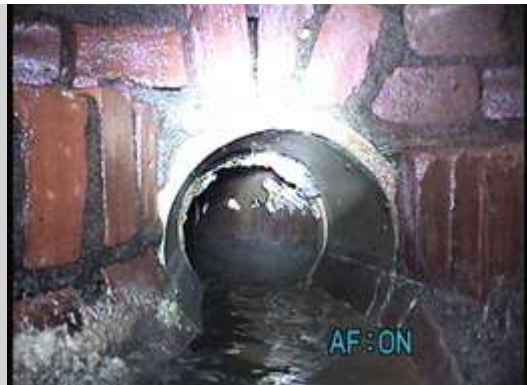
3 O'Clock Inflow

8 in. Circular Gravity Sewer
Pipe In @ 3 O'Clock

Pipe Height: **8.4** (in.) Rod and Bar (Angled)
Pipe Material: **Clay** ☐ Pipe Lined
Invert Depth: **12.45** (ft.) Flow Characteristics: **Fast**
Deposits: ☒ None ☐ Mud ☐ Sludge ☐ Debris ☐ Grease
Silt Depth: (in.) Deposits Extent:
Infiltration: **None** Pipe Seal Cond: **Sound**

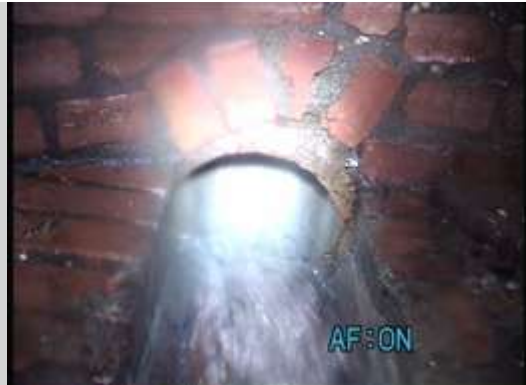
6 O'Clock Inflow

8 in. Circular Gravity Sewer

Pipe In @ 6 O'Clock

Pipe Height: **8.4** (in.) Rod and Bar (Angled)

Infiltration: **None** Pipe Seal Cond: **Sound**

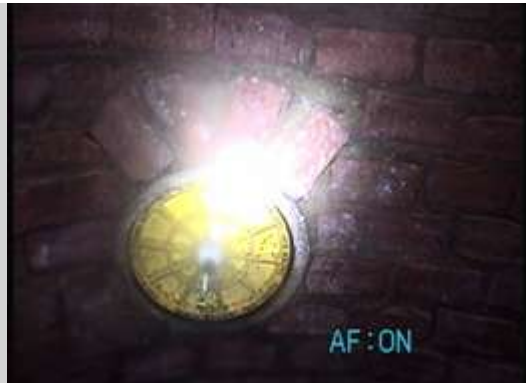
8 O'Clock Inflow

Pipe In @ 8 O'Clock

Pipe Material: **Clay** ☐ Pipe Lined

Infiltration: **None** Pipe Seal Cond: **Sound**

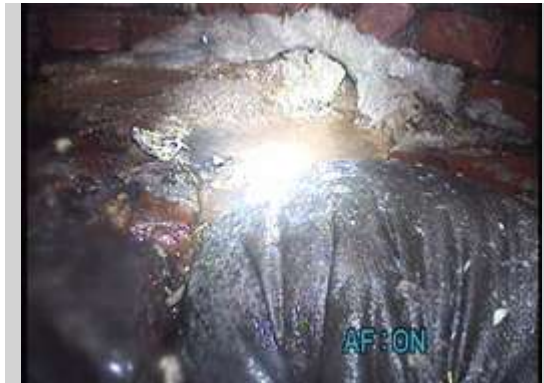
Drop In @ 8 O'Clock

Drop: **None**

Connects To: **Stub connection / abandoned**
